ZyPer Management Platform Release Notes

Software 2.3.37103

October 21, 2021

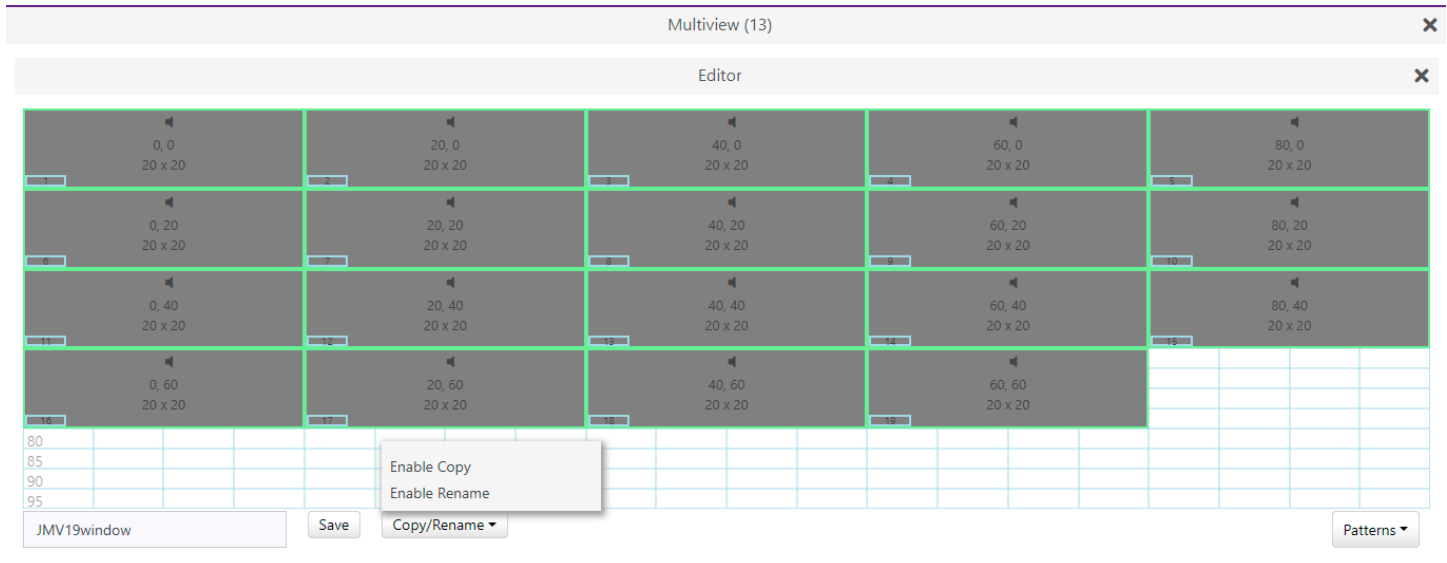
Operation:

Overview: In this release, we have added the ability to Copy/Rename Multiview configurations in the GUI. This function has been added to the Multiview edit menu and when selected will allow the user to copy a config to a different name or rename the existing Multiview (like the prior save as, feature in previous versions).

- 1) When you select copy, enter the new name you want to save to copy as
- 2) Click the "Copy" button below and you will see the new Multiview upon the menu exiting

- 1) When you select rename, enter the new name you want for the Multiview
- 2) Click the "Save" button to save the Multiview with the new name

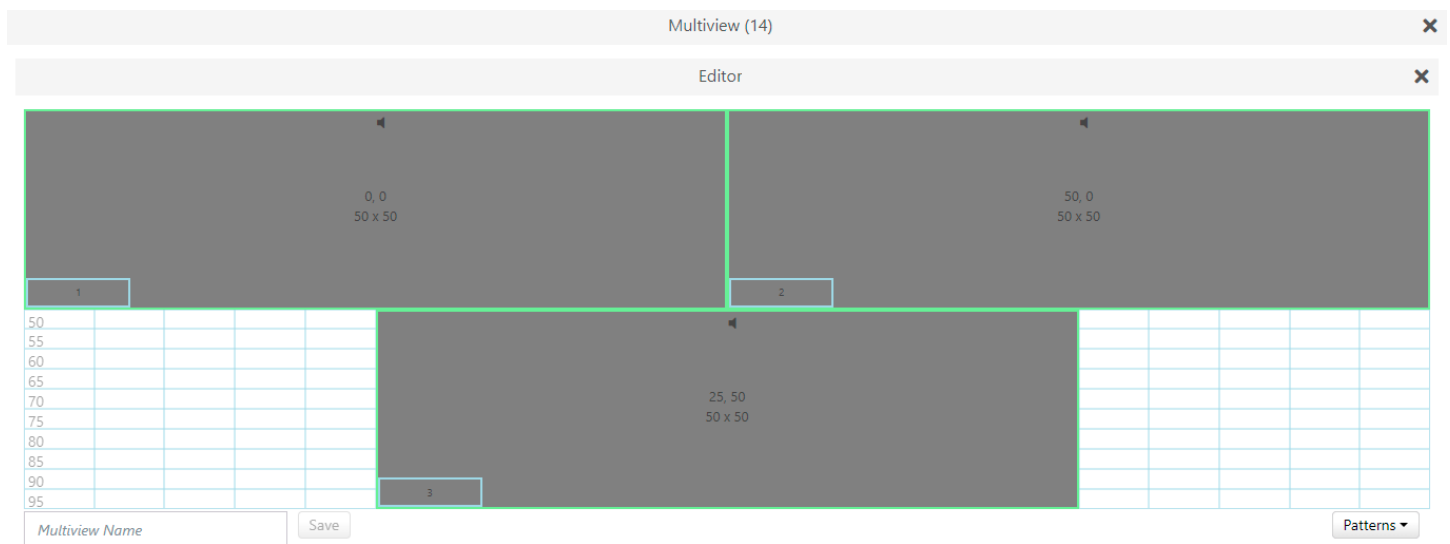
Two on top, one on bottom

Overview: In this release, we have added 4 new Multiview patterns to the standard set of configurations.

These new patterns were added to the “Pattern” drop-down button
