ZyPer Management Platform Release Notes

Software 2.5.3.38864

May 11th, 2023

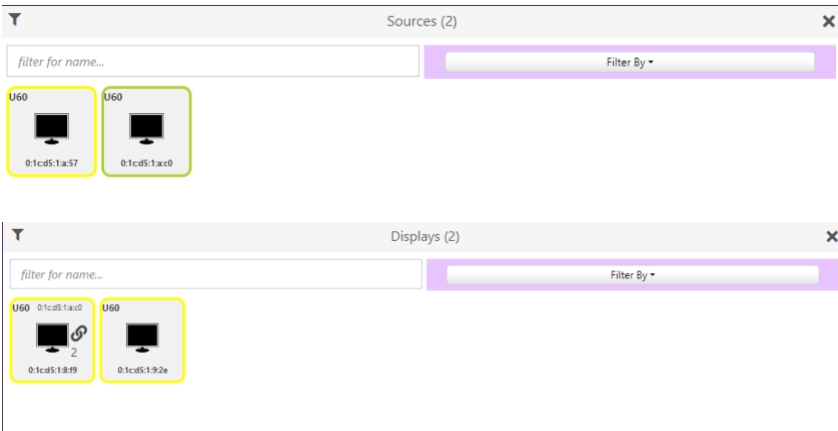
ZMP GUI changes include a new device type and configurations created for the ZyPerUHD60 product. A separate Join Configuration was created for this product so it will be unique. Along with these changes, a new Icon type of U60 was created for the ZyPerUHD60 which will be shown as U60 on the top left of the Icon under the source and display panels.

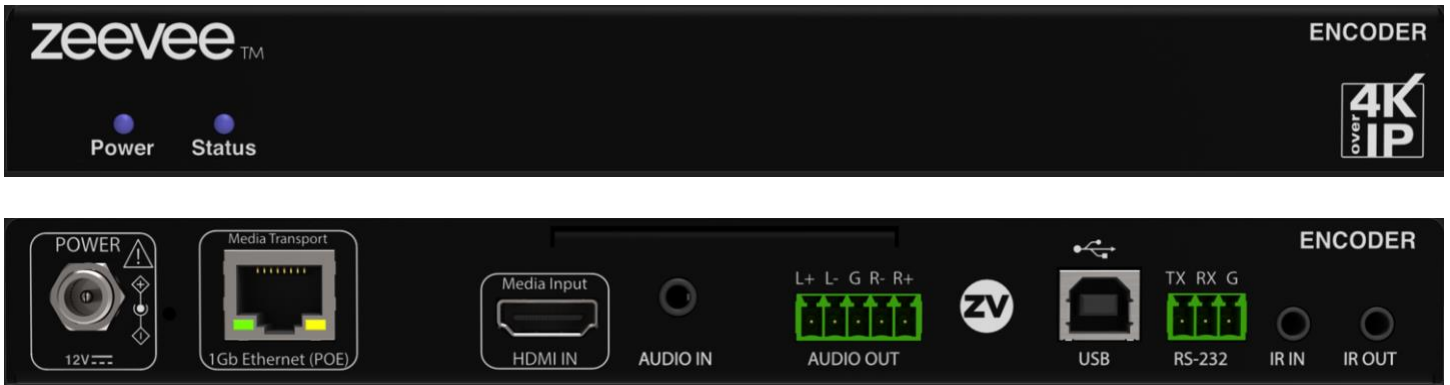
Encoder

Appearance:
