ZyPer Management Platform Release Notes

Software 4.0.40300

June 24th, 2024

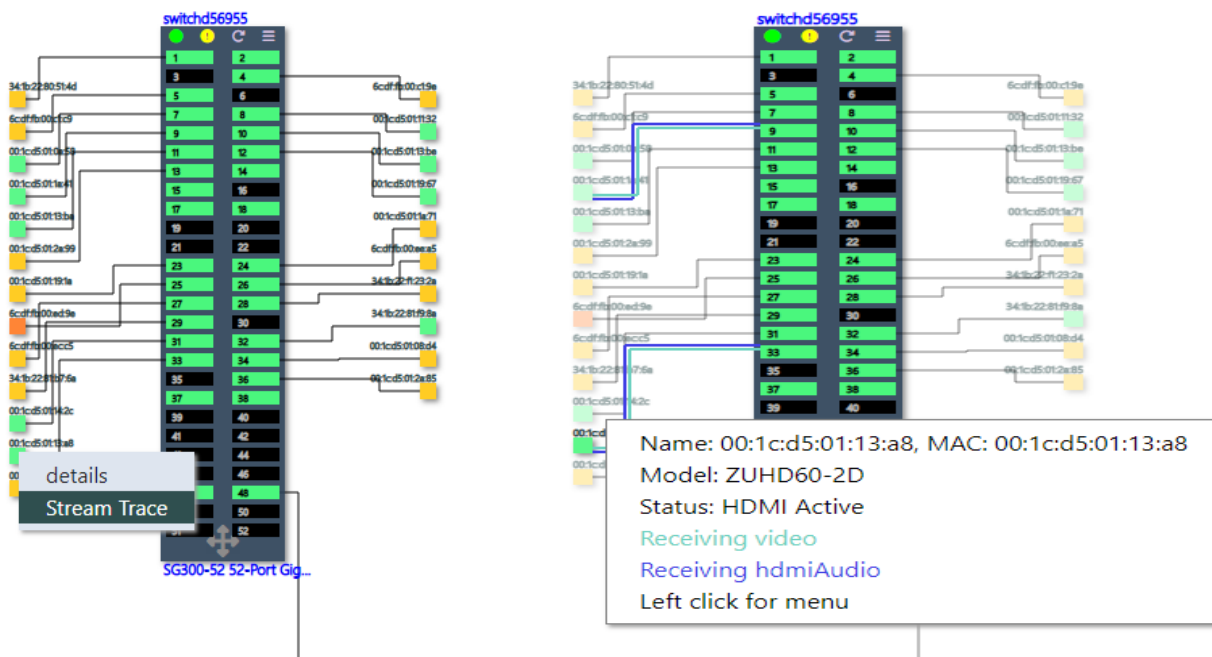
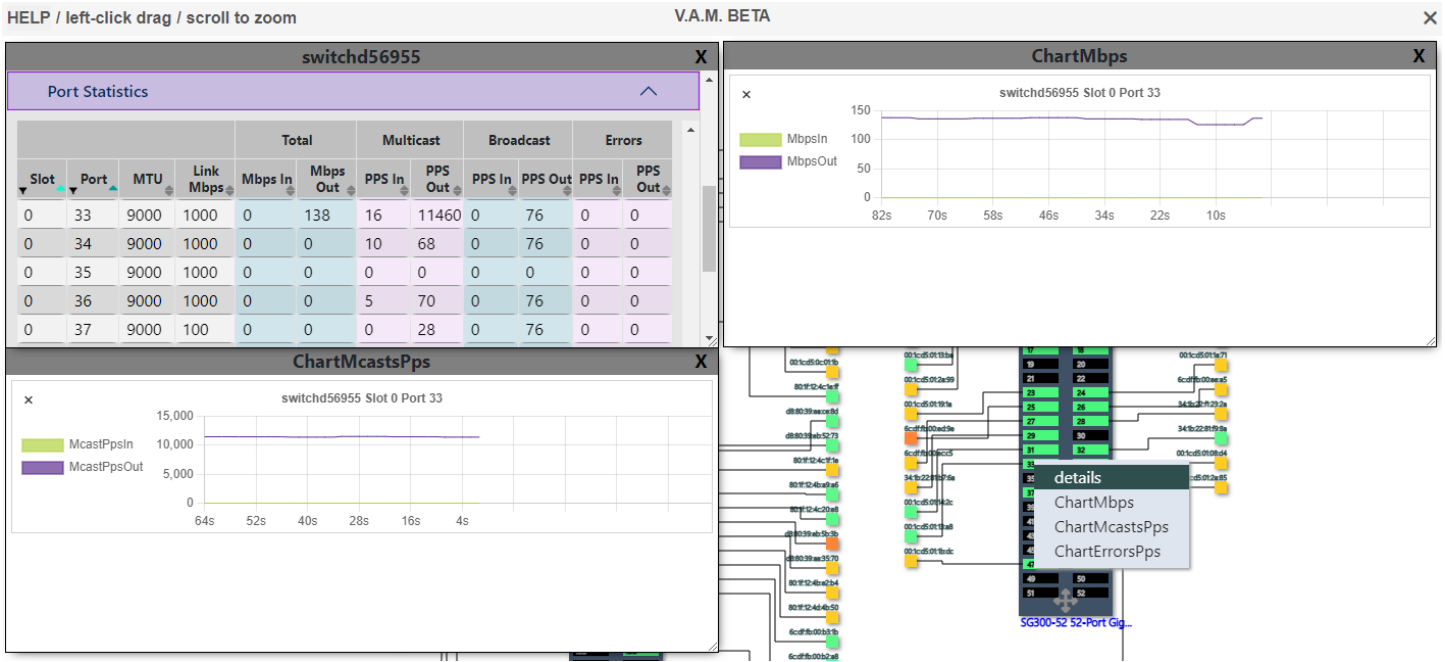
V.A.M. BETA

Analyze and Monitoring

Limitations: Only the Netgear M4300, Cisco 300SG switches are supported in this version of VAM

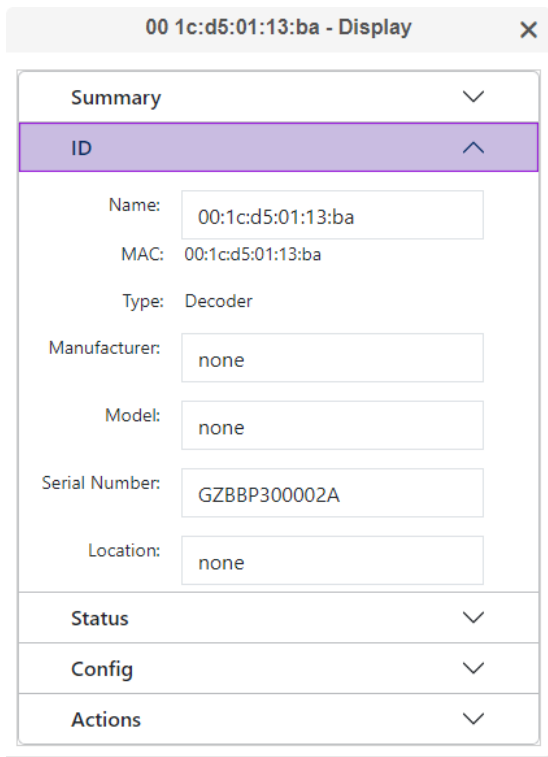
```
Zyper$ show device config 00:1c:d5:01:13:ba
device.gen; productCode=ZUHD60-2DA, productDescription=Copper Decoder+ - HDMI 2.0 Dante,
SN=GZBBP300002A
```

- **Under the GUI here is where the serial numbers are displayed.**

Limitations: This is limited to ZyPerUHD60 devices only.

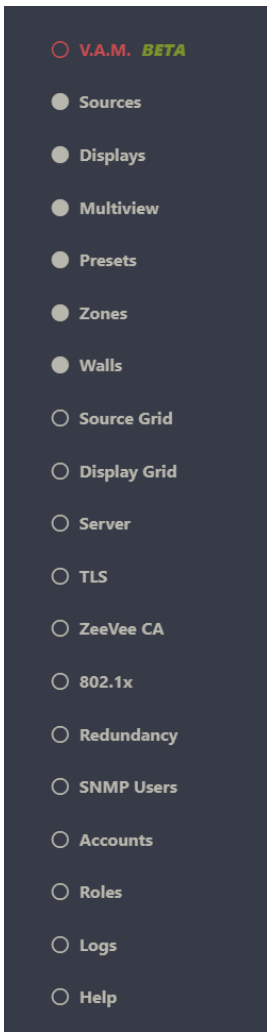
Adjusted main hamburger panel selection order

Operation and Appearance:

- Below are the current settings for the panel options
